Manhole Inspection Summary

Manhole # S17W__010MH

Insp Date: **6/24/08 10:27 AM**

Location Address: **2601 washington bd**

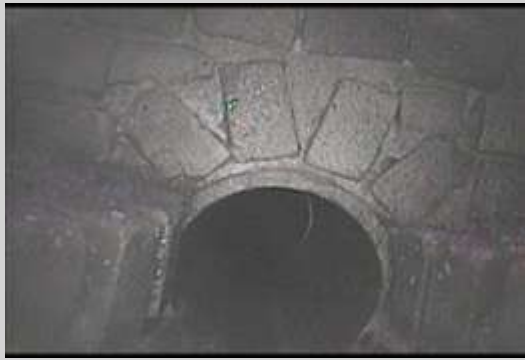
12 O'Clock Outflow

Pipe Height: **8.4** (in.) Rod and Bar (Angled)
Pipe Material: **Clay** ☐ Pipe Lined
Invert Depth: **10.89** (ft.) Flow Characteristics: **Slow**
Deposits: ☒ None ☐ Mud ☐ Sludge ☐ Debris ☐ Grease
Silt Depth: **0** (in.) Deposits Extent:
Infiltration: **None** Pipe Seal Cond: **Sound**

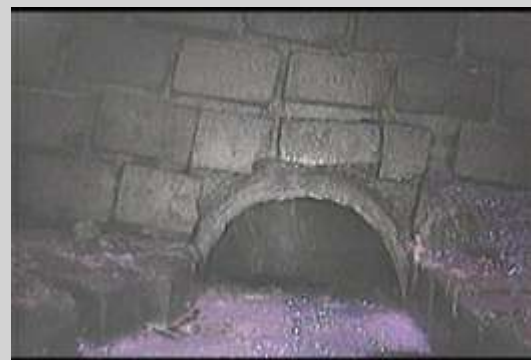
Drop In @ 3 O'Clock

Drop: **Outside** Rod and Bar
Angled: **Yes** Reading: **9.70** (ft.)
Inv Depth: **10.70** (ft.)

Drop Condition: **Open**

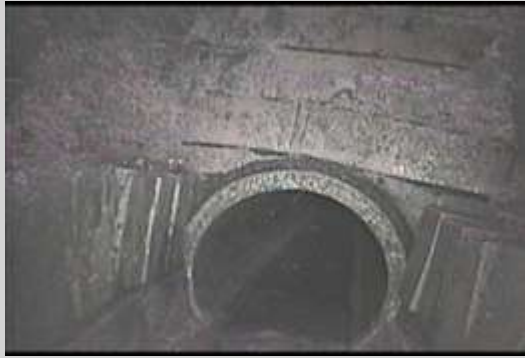
8 O'Clock Inflow

Pipe Height: **8.4** (in.) Rod and Bar (Angled)

Pipe Material: **Clay** ☐ Pipe Lined

Infiltration: **None** Pipe Seal Cond: **Sound**
